Manhole Inspection Summary

Manhole # S39Y1_009MH

Insp Date: **10/7/08 11:29 AM**

Location Address: **3600 5th St.**

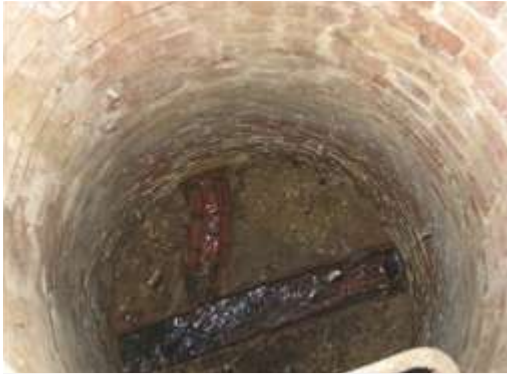
Defect 1

debris on bench

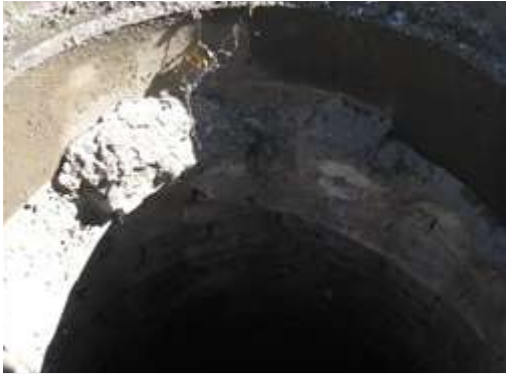
Defect 2

frame infiltration

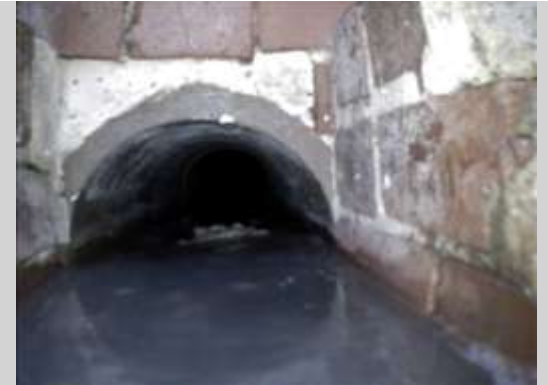
12 O'Clock Outflow

Pipe Height: **10.8** (in.) Rod and Bar (Angled)
Pipe Material: **Clay** ☐ Pipe Lined
Invert Depth: **9.34** (ft.) Flow Characteristics: **Slow**
Deposits: ☒ None ☐ Mud ☐ Sludge ☐ Debris ☐ Grease
Silt Depth: (in.) Deposits Extent:
Infiltration: **None** Pipe Seal Cond: **Sound**

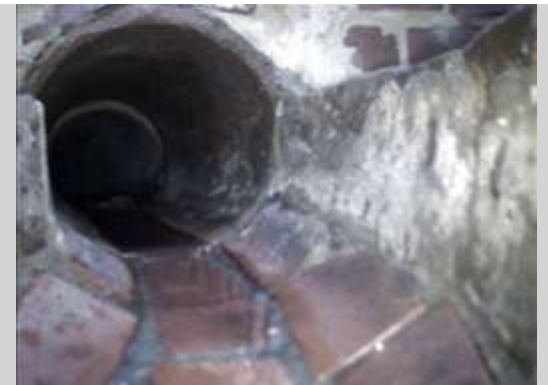
3 O'Clock Inflow

Pipe Height: **9.6** (in.) Rod and Bar (Angled)
Pipe Material: **DIP/CI** ☐ Pipe Lined
Invert Depth: **8.78** (ft.) Flow Characteristics: **Slow**
Deposits: ☒ None ☐ Mud ☐ Sludge ☐ Debris ☐ Grease
Silt Depth: (in.) Deposits Extent:
Infiltration: **None** Pipe Seal Cond: **Sound**

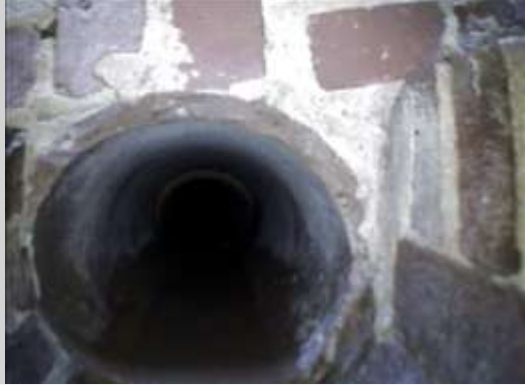
6 O'Clock Inflow

Pipe Height: **7.2** (in.) Rod and Bar (Angled)

Pipe Material: **Clay** ☐ Pipe Lined

Invert Depth: **9.00** (ft.) Flow Characteristics: **Slow**

Infiltration: **None** Pipe Seal Cond: **Sound**
